MEMOIRS OF AN AERONAUTICAL ENGINEER

**Flight Tests at Ames Research Center:
1940-1970**

Seth B. Anderson

National Aeronautics and Space Administration
Monograph in Aerospace History Series #26

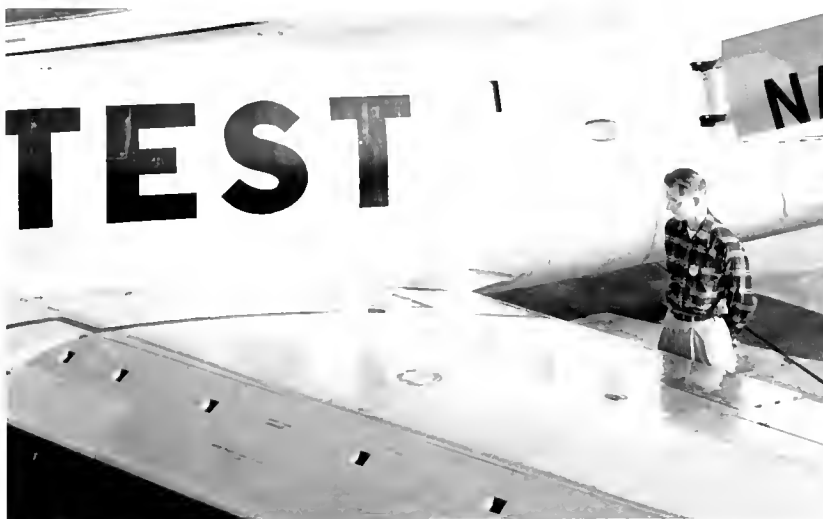
Vortex generators mounted on the wing of a North American YF-86D.

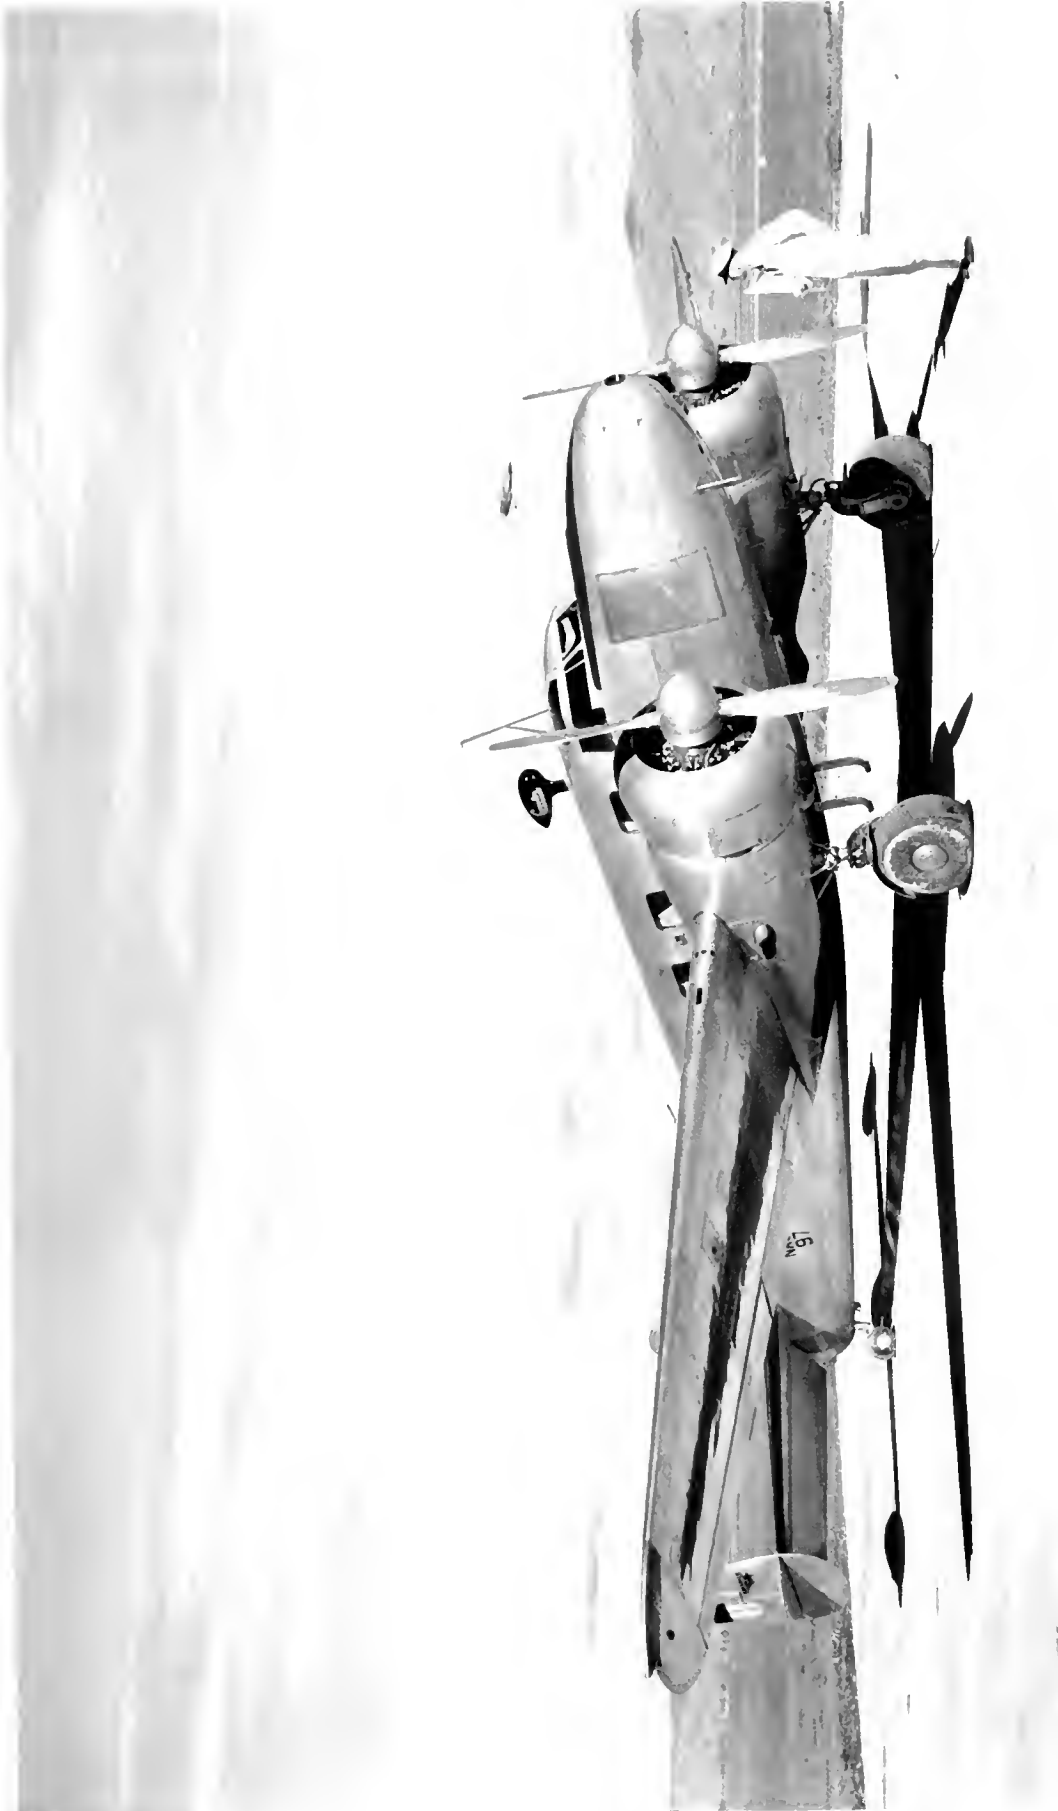
Figure 15. The Lockheed 12A powered by Pratt & Whitney 450-horsepower engines. This aircraft was flown in very severe icing conditions after modification by the Lockheed Company to provide hot air deicing for the wings. An instrumented third vertical tail (barely visible in the photo) was added by Ames to study ice protection for this part of the aircraft.

The second aircraft tested early in 1941 was a Lockheed 12A Electra which had been modified by Lockheed for use in conducting icing research in detail (fig. 15). Engine exhaust pipes, running through the wings' leading edges, heated the wing skin to prevent the formation of ice. The aircraft was flown into the most severe known icing conditions in tests that proved the feasibility of the exhaust heat method. This icing project was unique in that this was the first time a NACA research program was taken into the proof-of-concept stage in order to help solve a major flight operational problem. The thermal ice prevention system won the 1947 Collier Trophy, an annual award commemorating the most important achievement in American aviation. The people in Ames' Flight Engineering Section had demonstrated the value of flight testing in achieving important results.

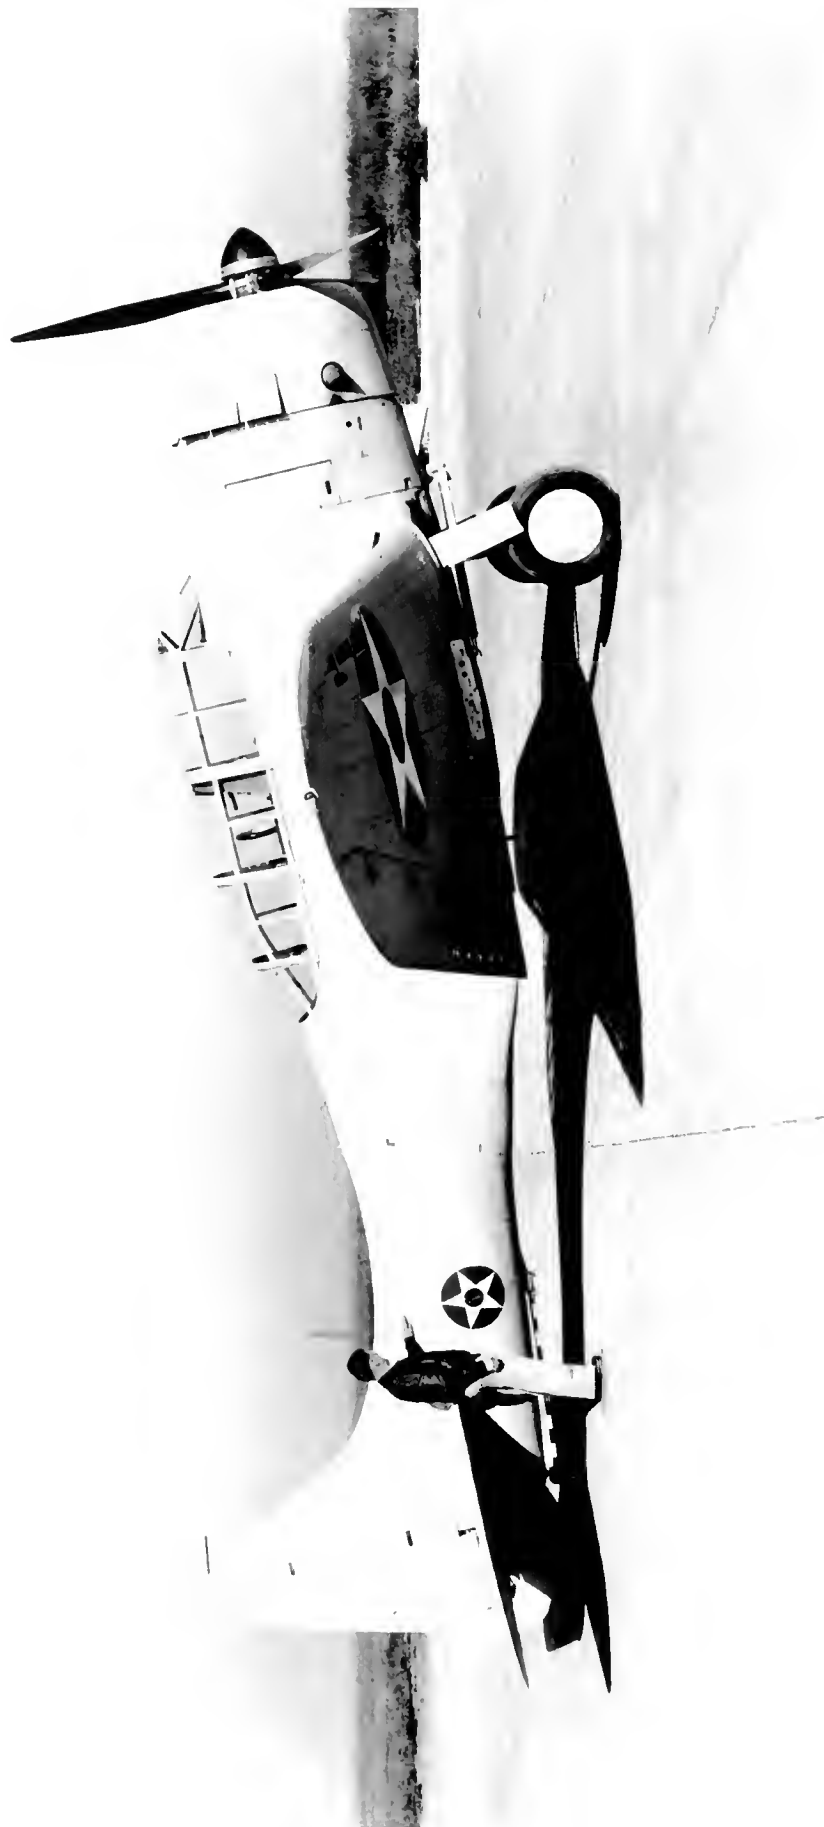
Figure 16. The Douglas SBD-1 Dauntless was the first aircraft used exclusively for handling-qualities research at Ames. This aircraft had low drag and was flown to 400 mph (0.70 Mach) in stability and control tests. (Oct. 1941) AAL-1646

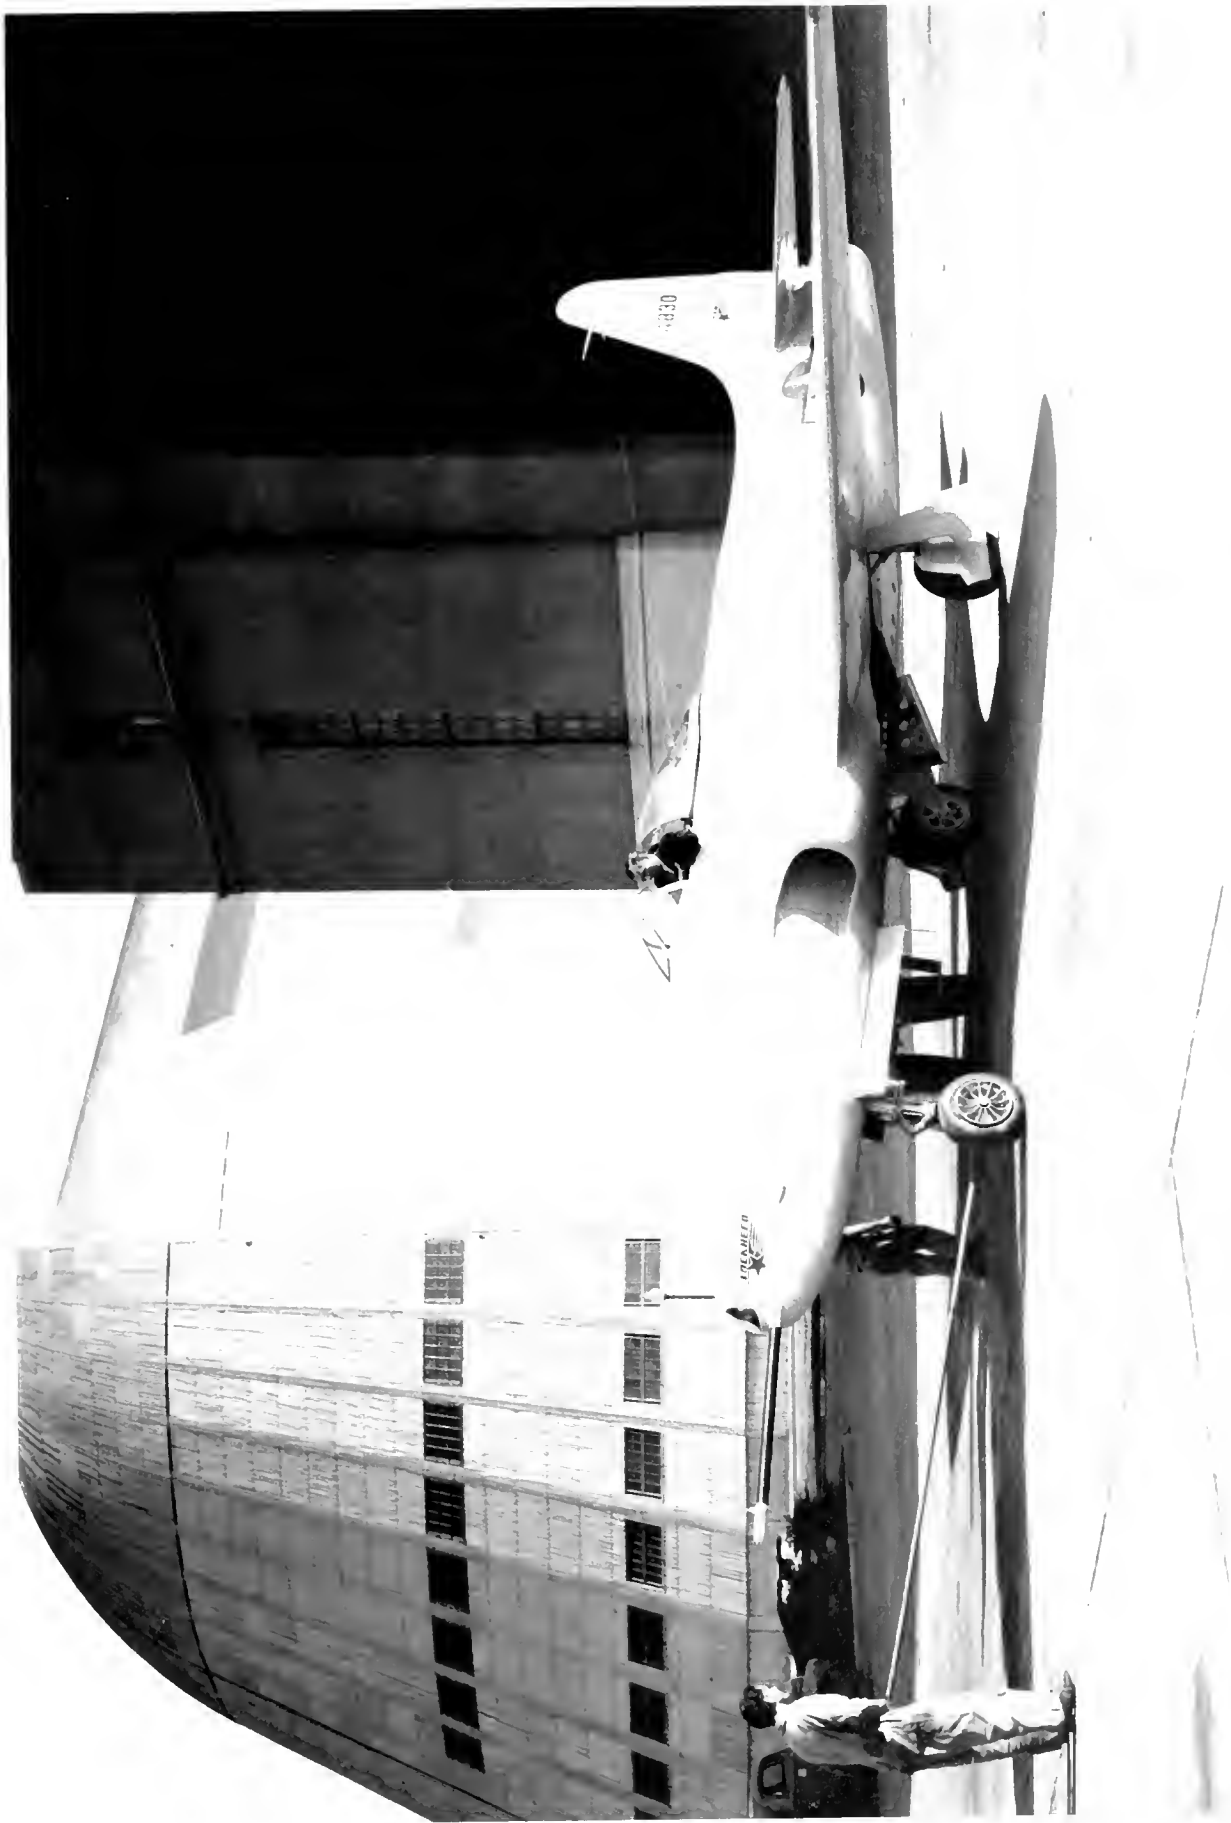
Figure 25. Lockheed XP-80 "Secret" airplane pushed out from the south end of building N-210. It arrived in September, 1944, and was instrumented in a secured "Blue Room." It was powered by a (J-33) turbojet engine and was flown to Mach 0.866, a speed record for the time (1946). A-6-76

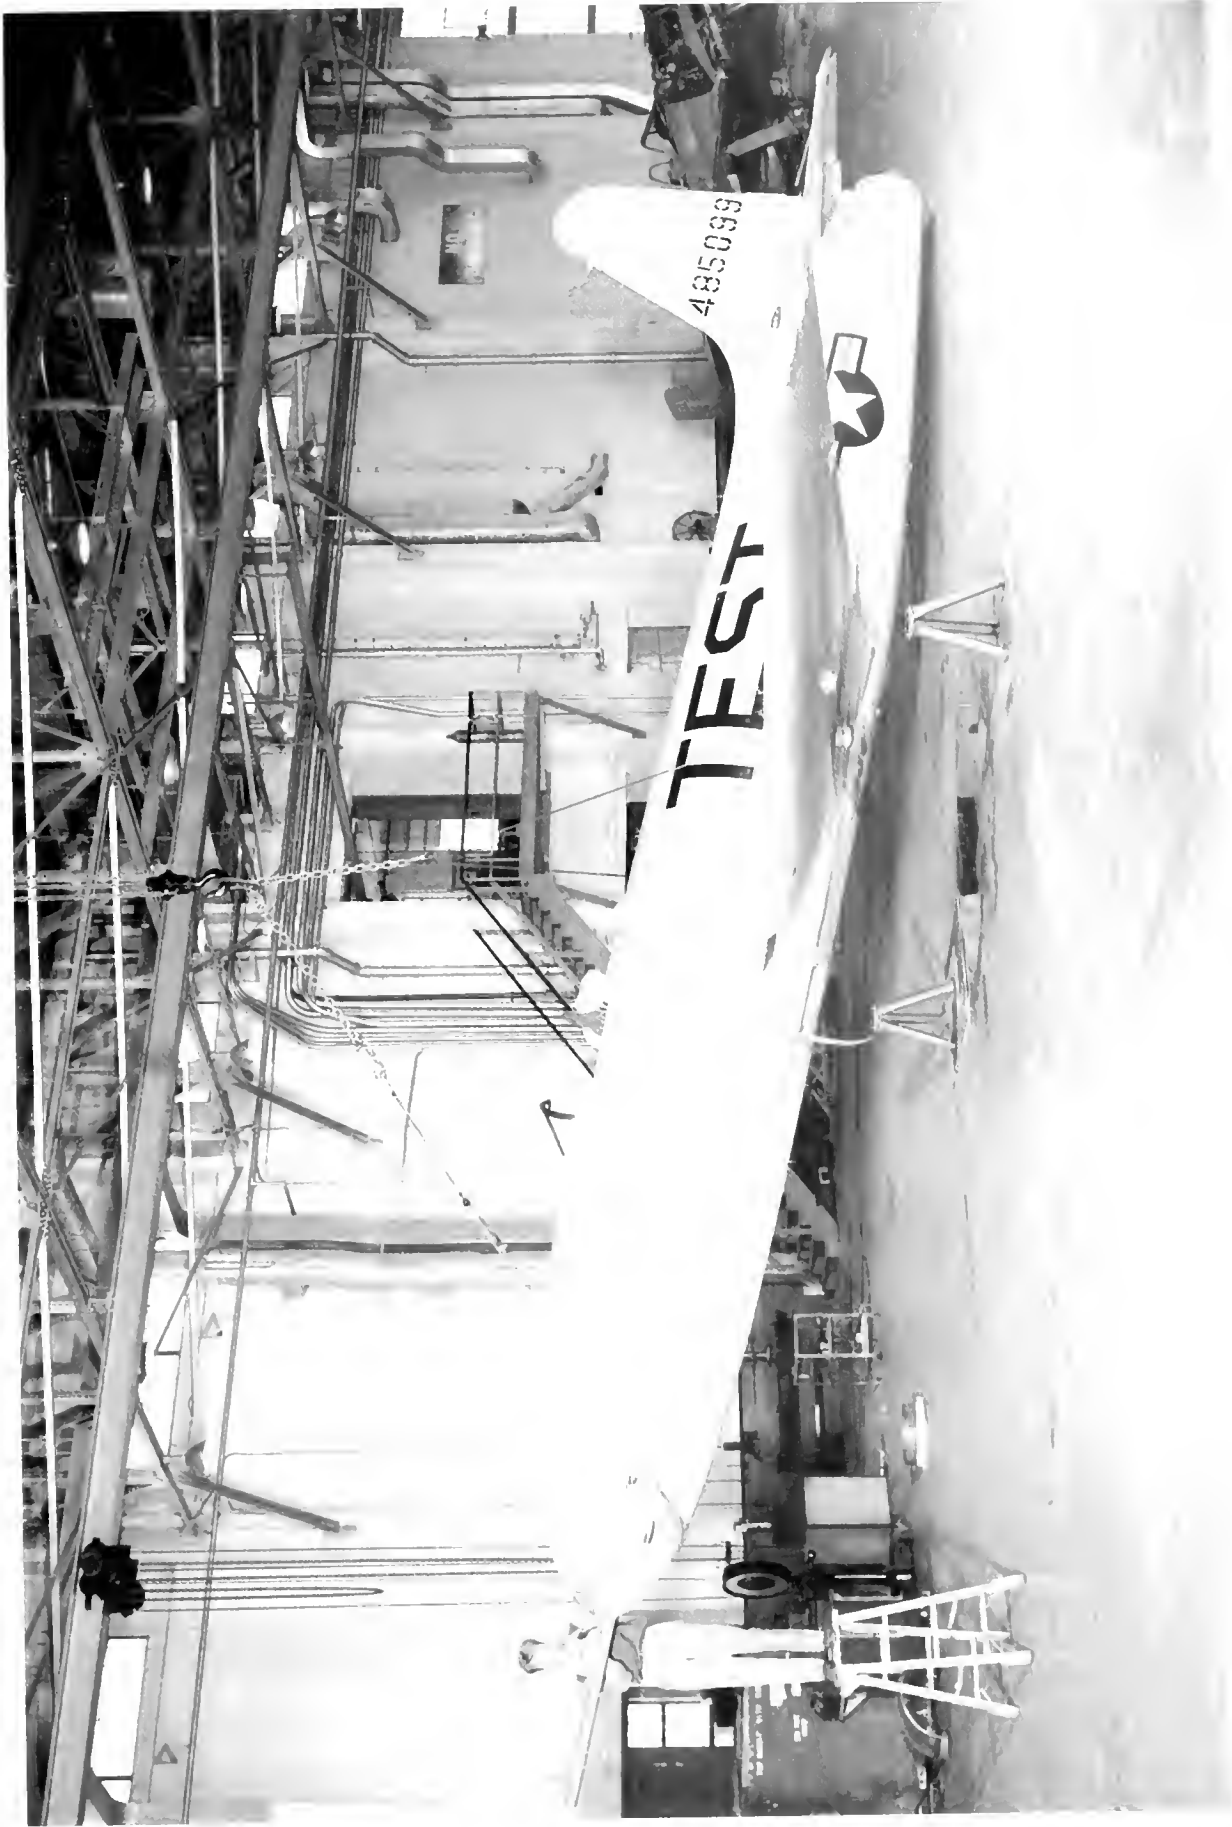
Figure 27 Measurements being taken to obtain the vertical center of gravity of the Lockheed P-80A by weighing the aircraft in nose-up and nose-down positions with the landing gear retracted. The cockpit canopy is missing. Stairs leading to the second floor loft in building N-210 are in the background. Aug. 1947. A-11935

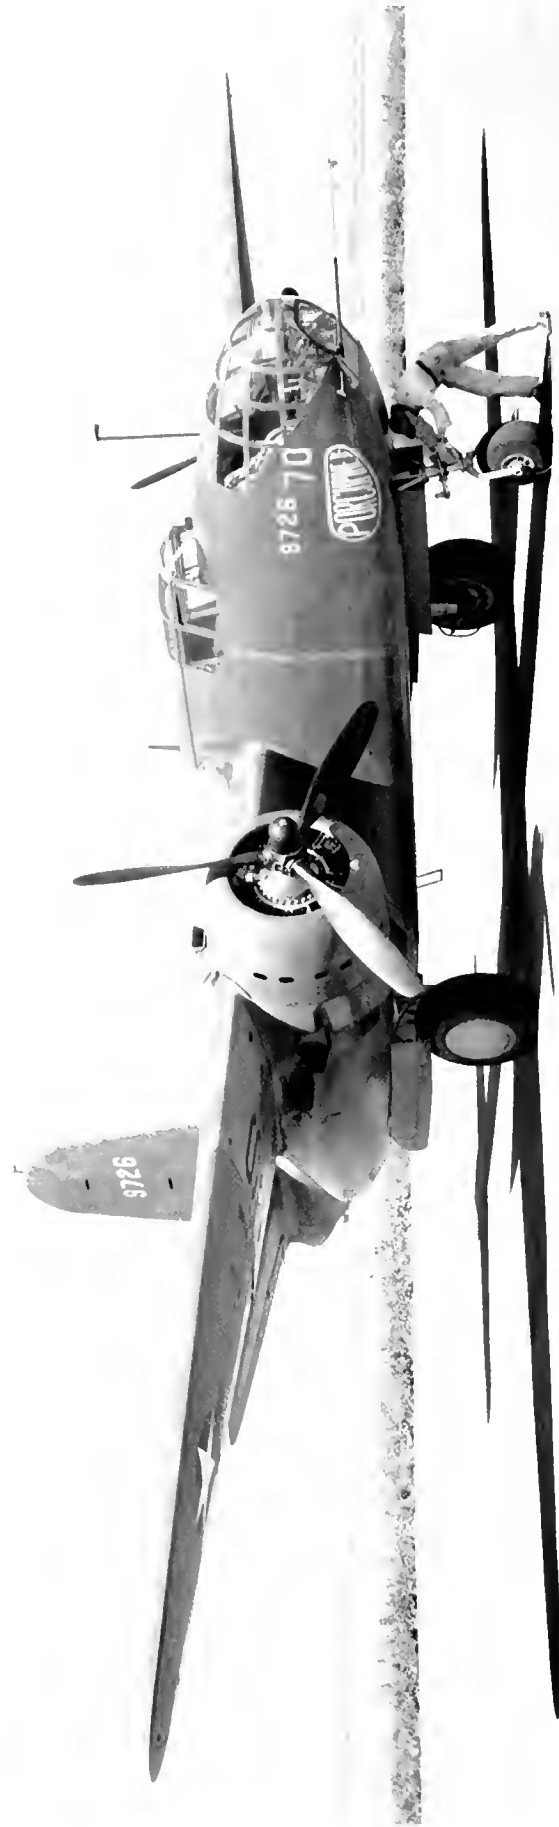
Figure 30. Douglas A-20A Havoc with yaw vane and airspeed swivel head installed on a fuselage nose boom. Flutter motion of the vanes could not be observed from the pilot's cockpit. A yaw vane is on top of the mast in front of the pilot's windshield. Cockpit entrance and egress were through the bomb bay. (Apr. 1943) AAL-3913

for vibration tendencies, and because the boom could not be seen from the pilot’s position (fig. 30), I unbuckled my parachute and crawled forward from the rear cockpit and occupied the navigator seat to observe the boom through the clear acrylic in the nose of the aircraft. After several dives to speeds approaching 400 mph with rates of descent over 25,000 feet per minute, I noted the onset of unsteadiness in the free-swiveling vane system. Since there was no direct escape from the nose area, I quickly returned to the rear cockpit after the aircraft had returned to level flight and slipped into my parachute harness for the flight back to Moffett.

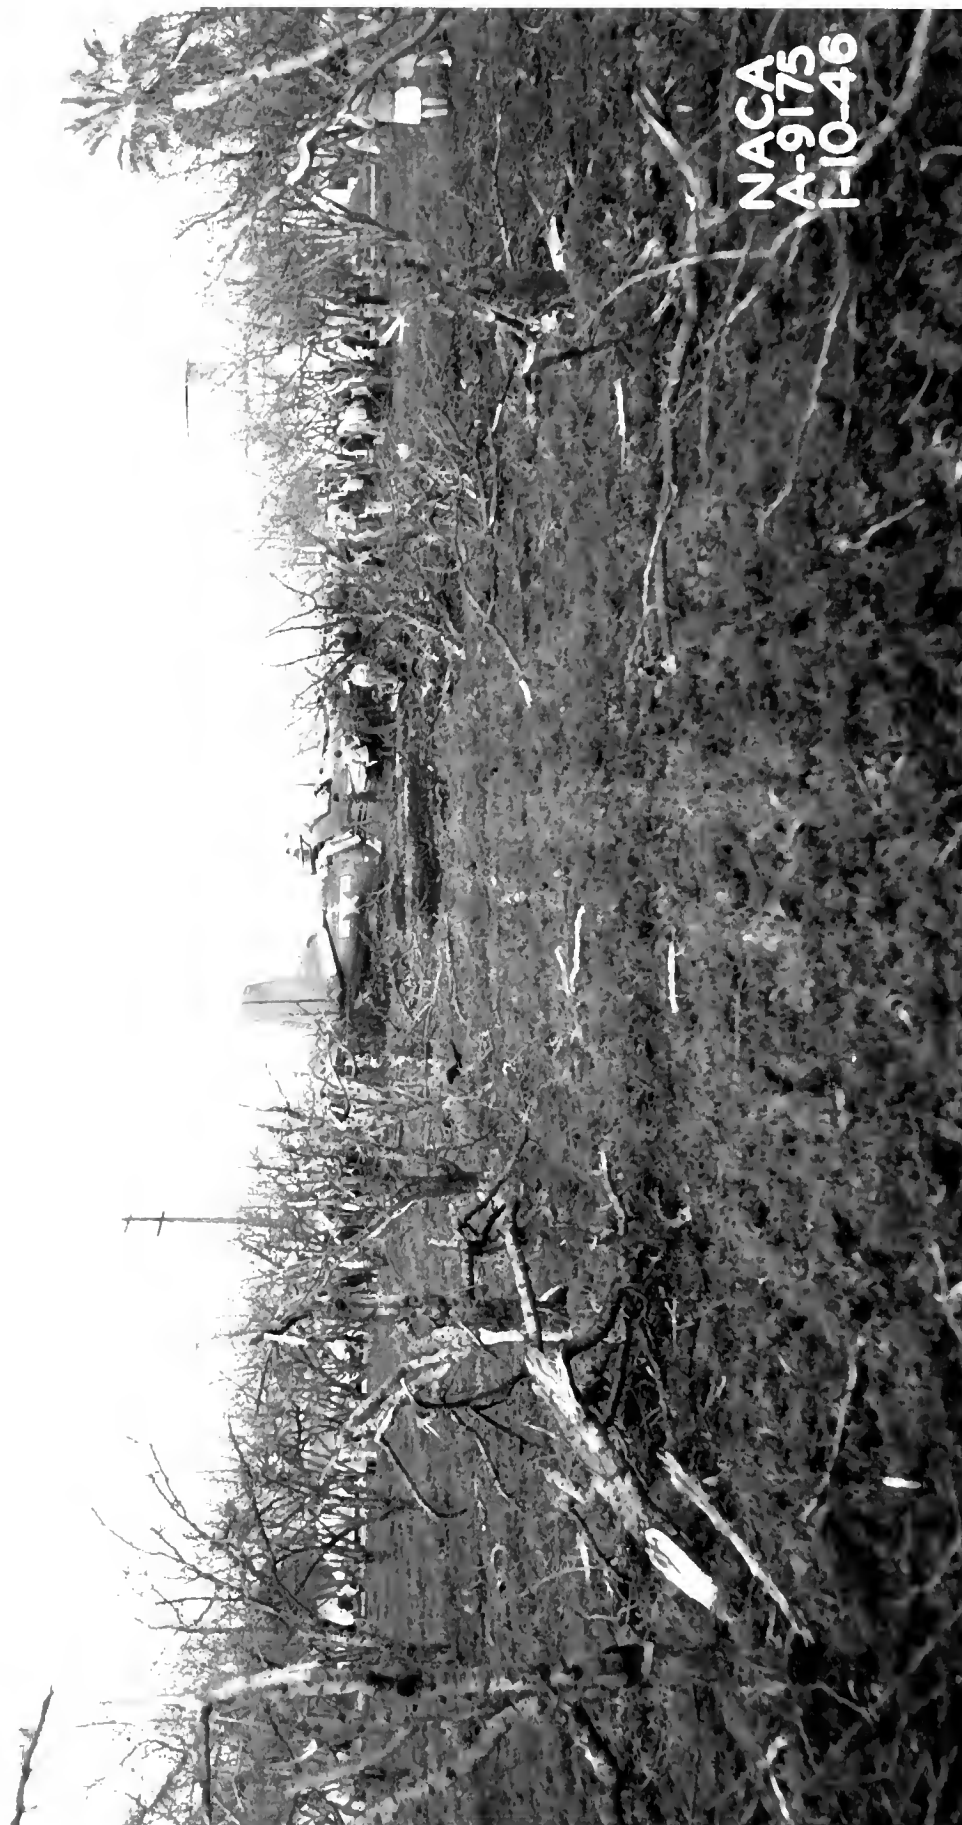
Figure 32. Crash landing of a Douglas XSB2D-1 in an orchard in Sunnyvale, California (near Moffett Field), caused by engine failure. Note the spectator crawling into the rear cockpit to remove the clock. (Jan. 1946) A-9175

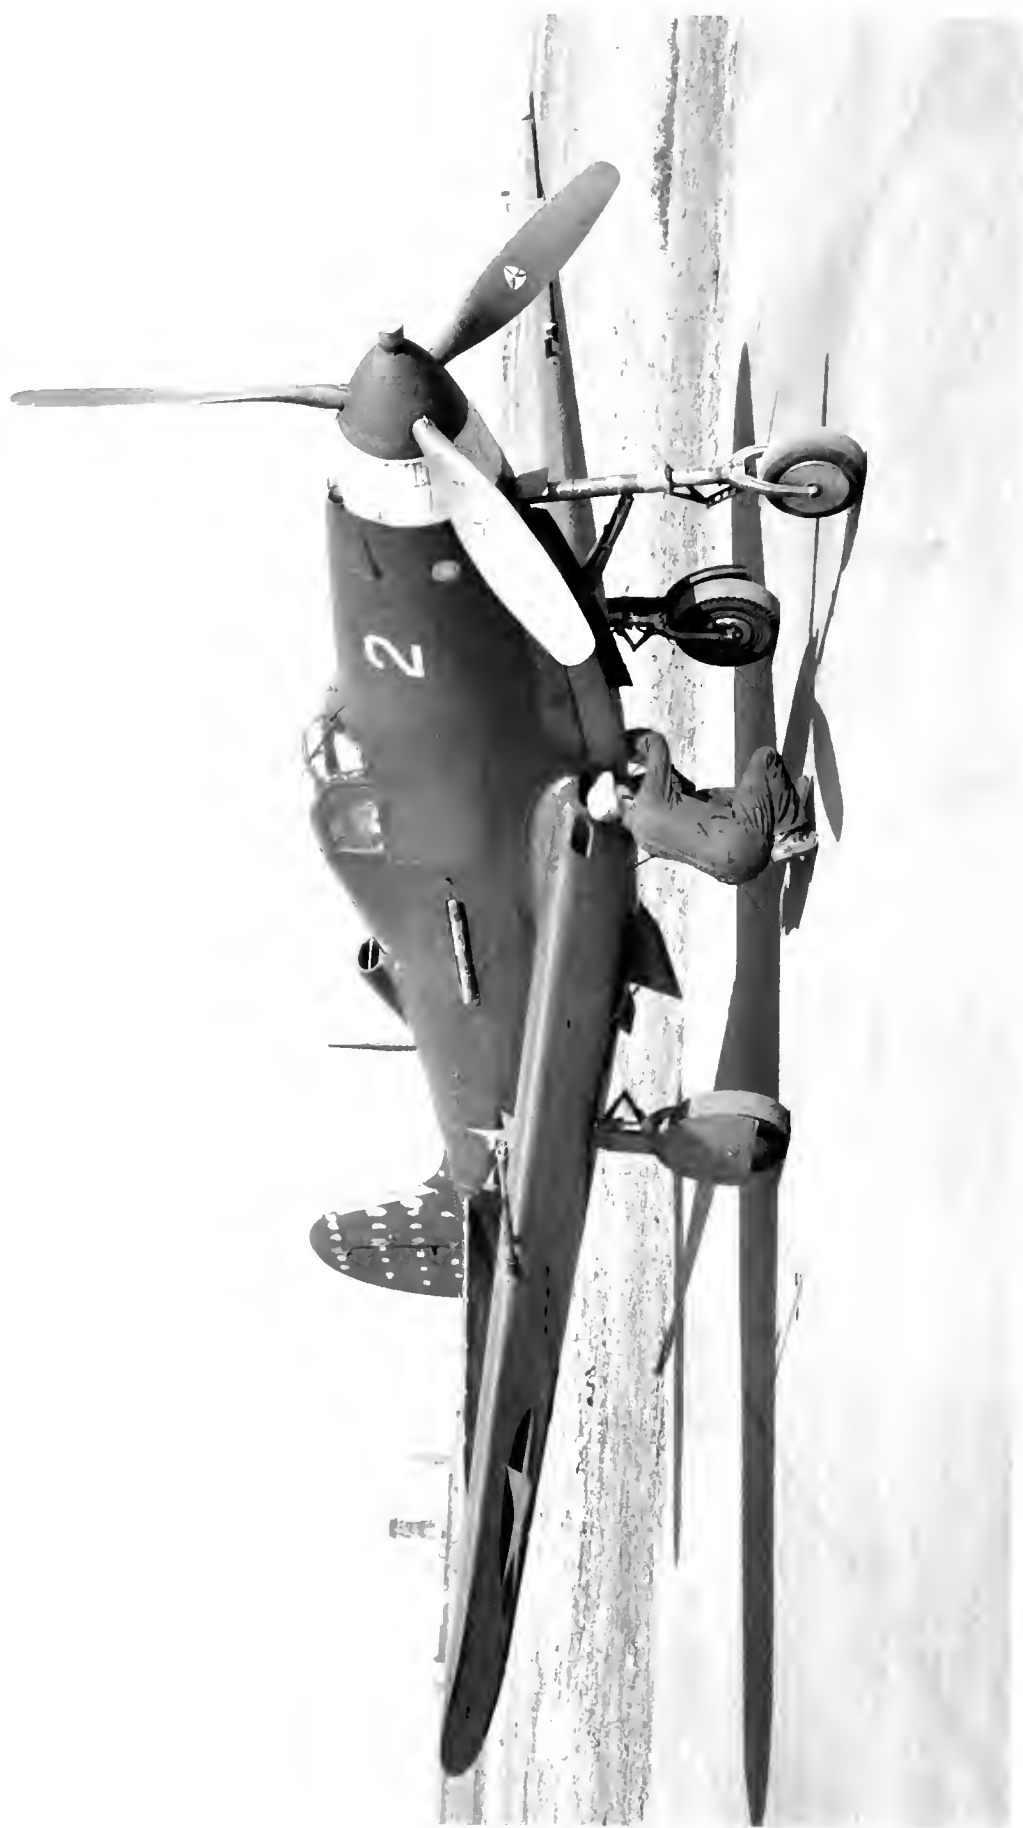
Figure 39. Bell P-39 Causes of vertical tail failure in maneuvering flight of the P-39 Airacobra were investigated. An Allison liquid-cooled engine was located behind the pilot and connected to the propeller gearbox by a long driveshaft. This allowed for the installation of the 37-mm cannon extending through the propeller spinner. (Jan. 1943) AAL-4599

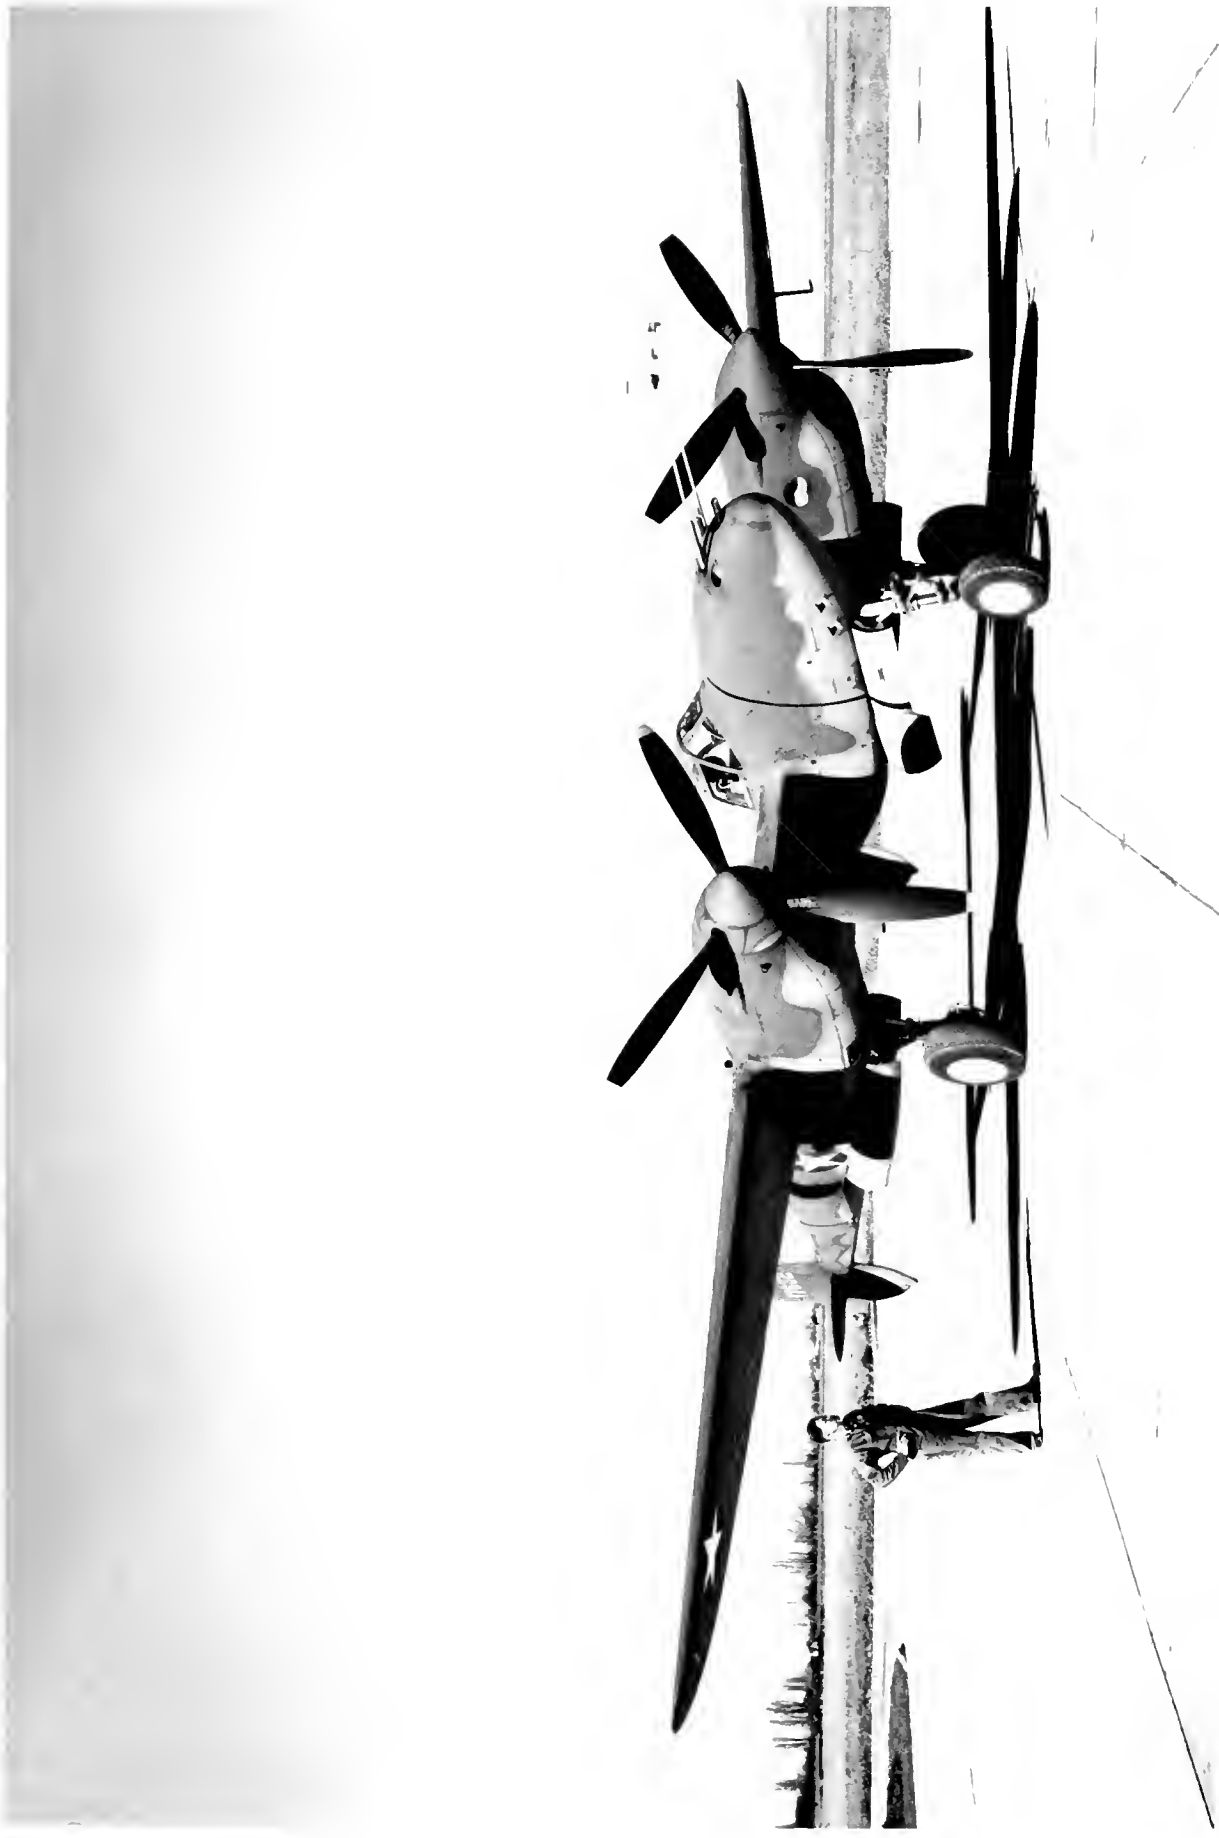
Figure 40. The Lockheed P-38J-15 Lightning shown with research instrumentation booms for use in handling-qualities tests. The free-swiveling airspeed head corrected flow misalignment caused by angle of attack and sideslip. The long booms tended to vibrate excessively at high airspeeds. (Aug. 1944) AAL-3507

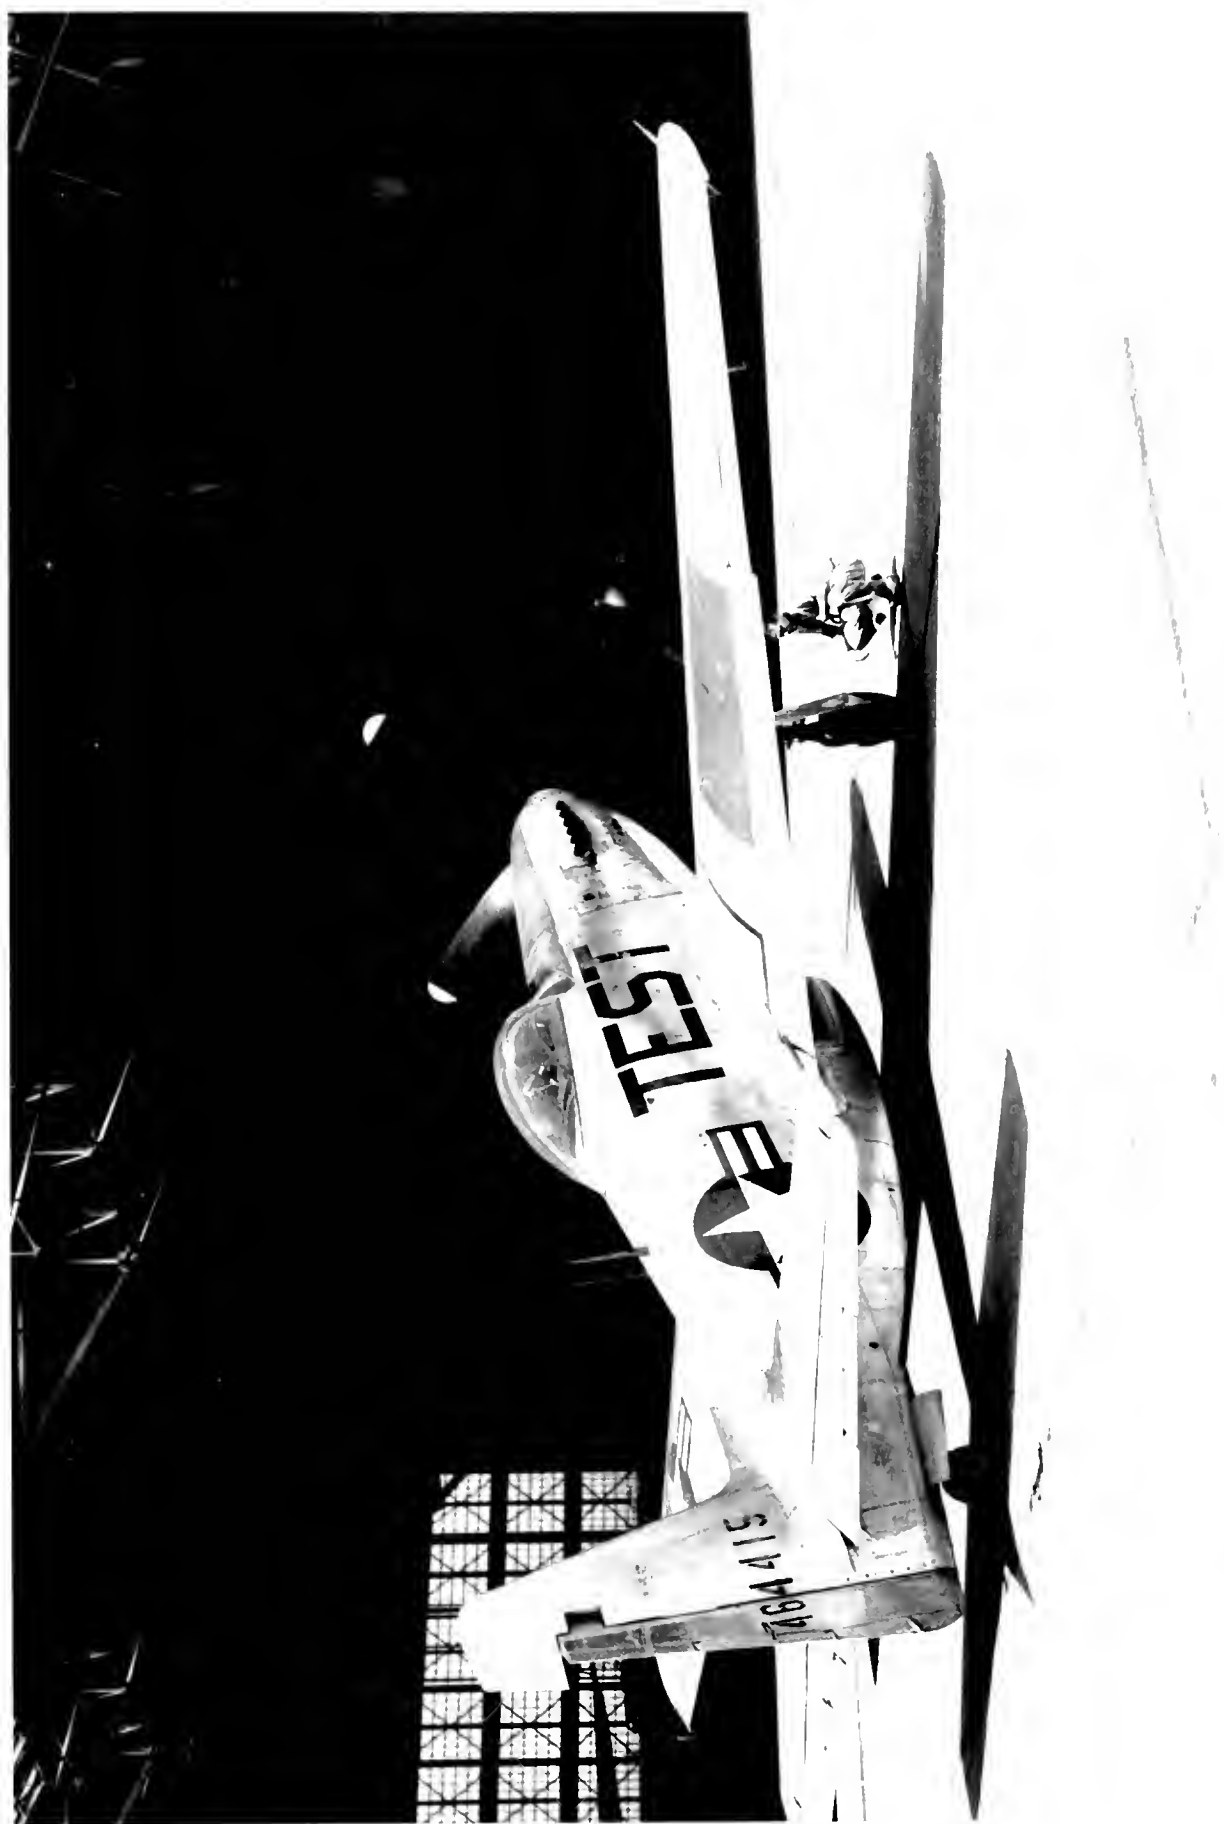
29 Figure 41. This North American P-5111 was used to test negative trailing-edge flap deflection as a means of improving pitch control in Mach 0.81 dives. A small reduction in diving tendency was noted. (June 1947) A-11703

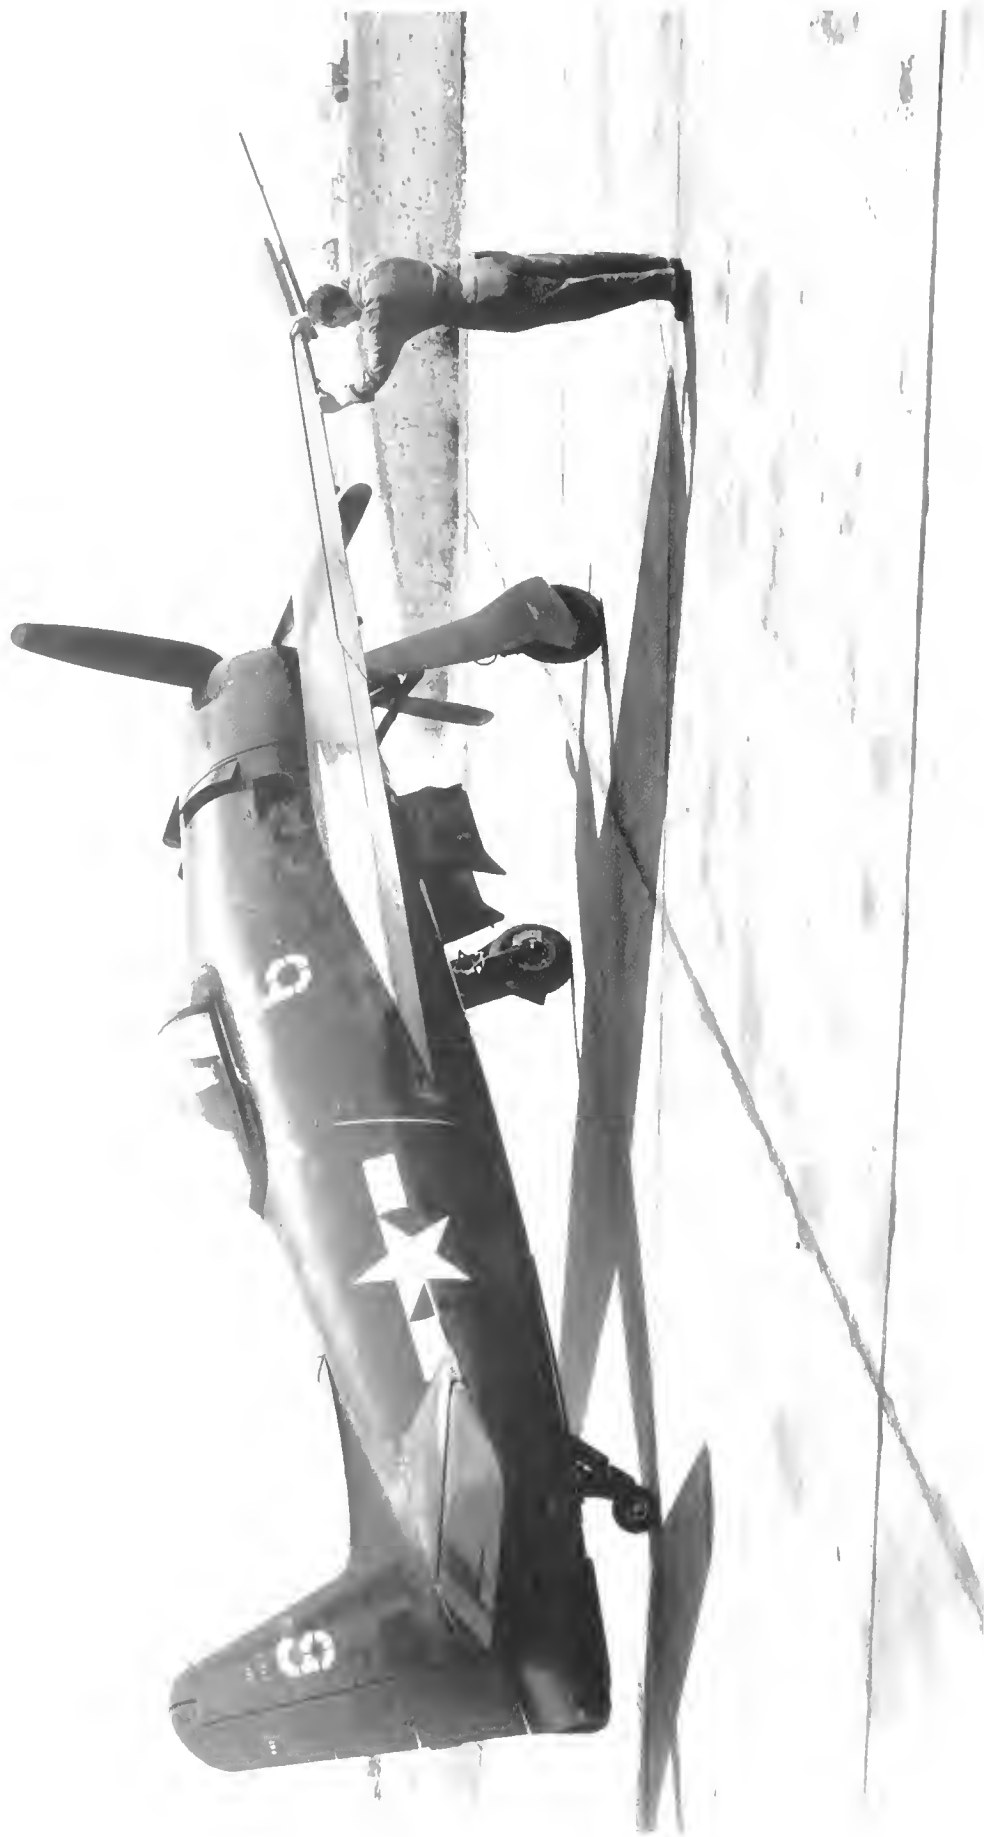
Figure 42. Grumman F8F-1 Bearcat was used in tests of reflexed trailing-edge flaps. No improvement in pitch control was noted at transonic Mach numbers.
(July 1947) A-11695

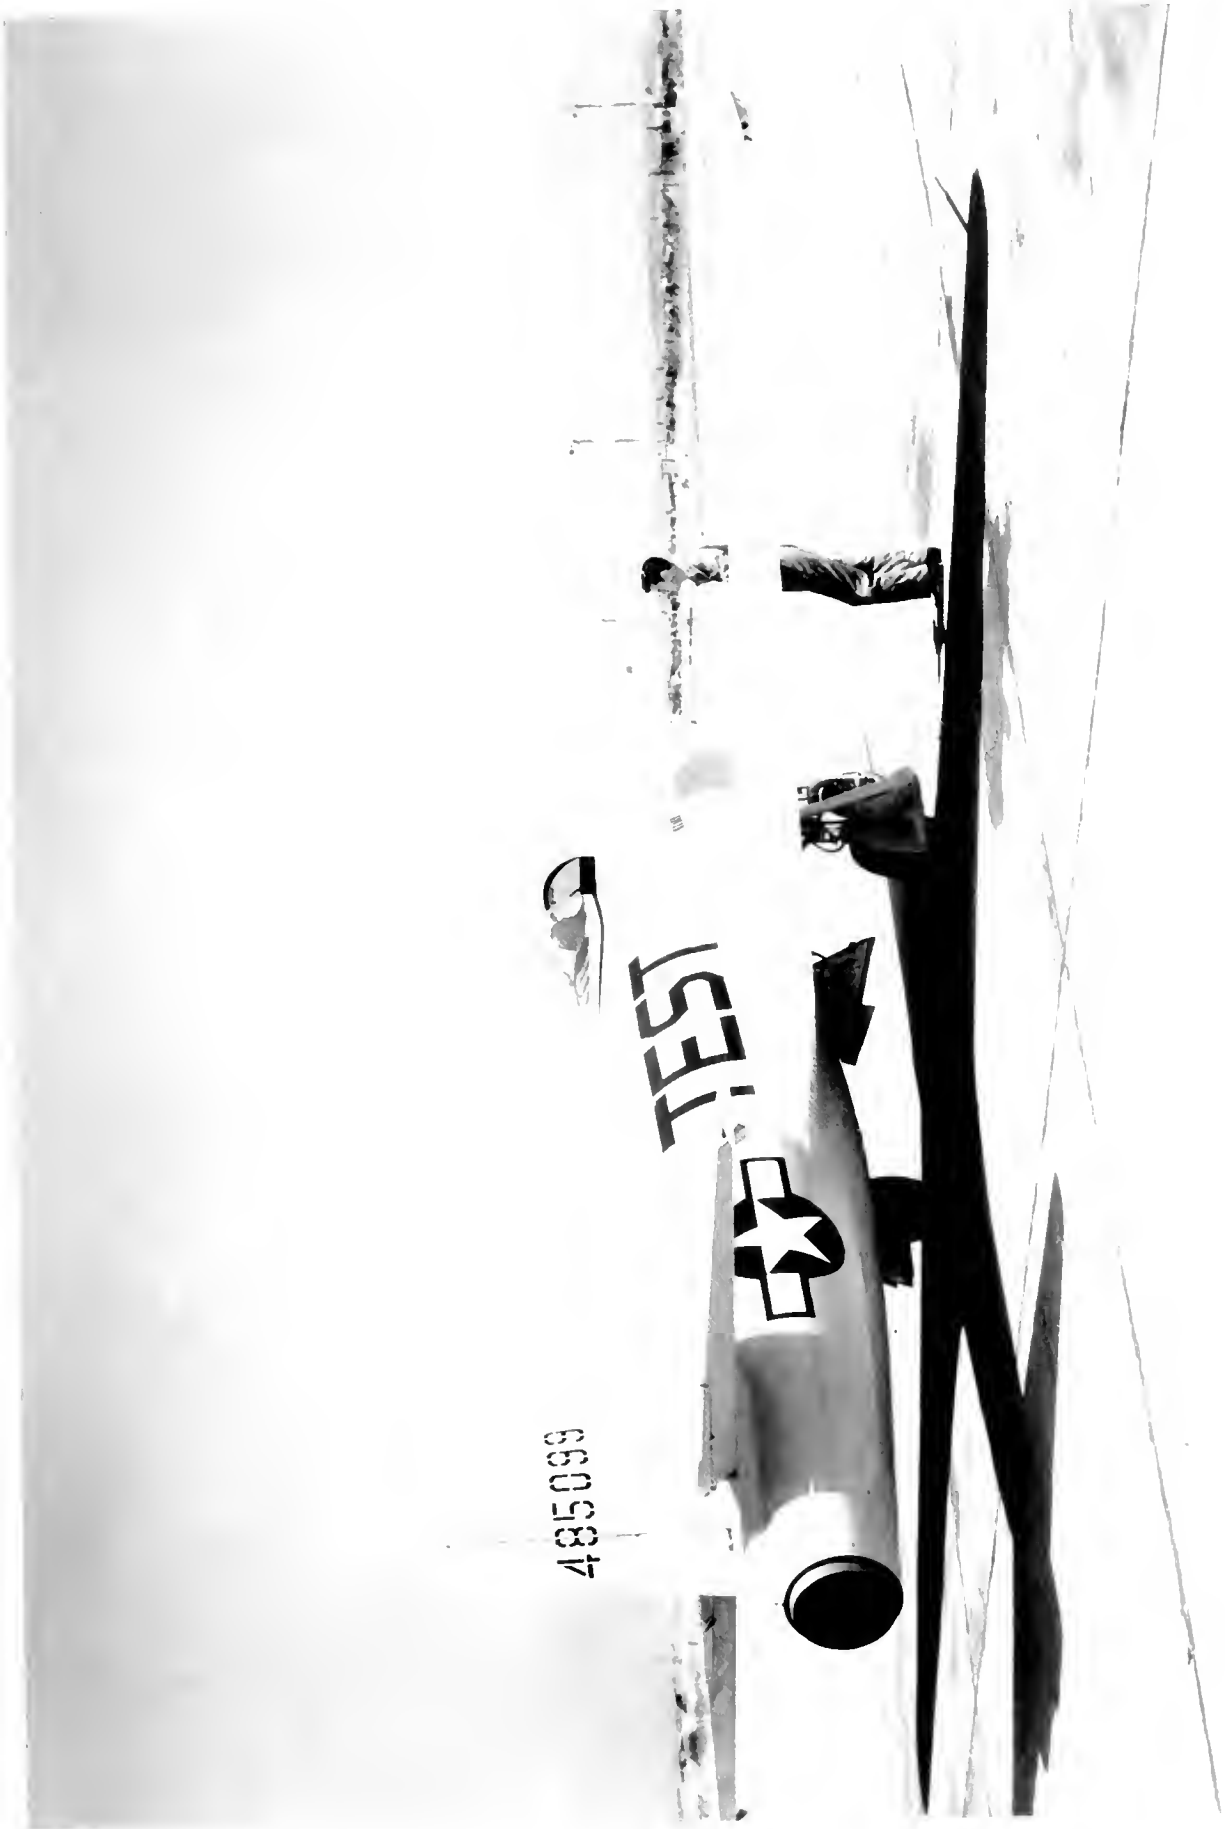
95 Figure 47. The Lockheed P-80A had a strong diving tendency starting at Mach 0.78 (see fig. 48). (Oct. 1951) A-10141
